## Ecoroof EdVenture

PROJECT:	Edmonton Valley Zoo – EdVenture Lodge
LOCATION:	Front Plaza Buildings, EdVenture Lodge and Cafe, Edmonton Valley Zoo, 13315 - Buena Vista Rd
BUILDING TYPE:	Commercial – Education centre and cafe
TOTAL ROOF AREA:	860 m <sup>2</sup>

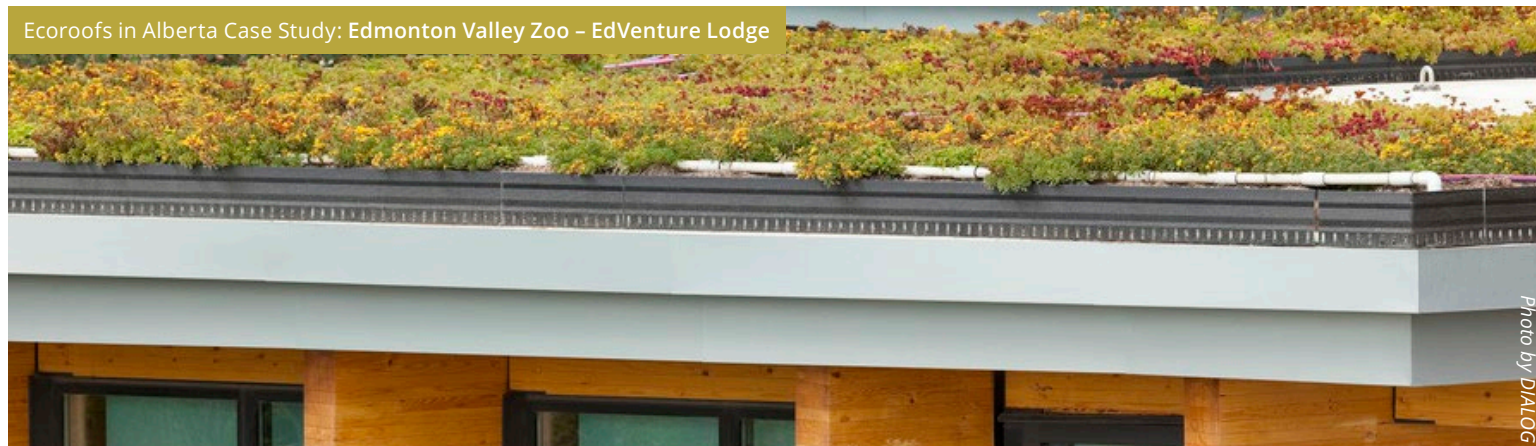
The ecoroof is located at the entrance to the Edmonton Valley Zoo. It goes hand-in-hand with the Rammed Earth Wall at the front depicting the banks of the North Saskatchewan River with the green at top of bank being represented by the ecoroof.
