Even the roofs are green at this golf course

PROJECT:	Victoria Golf Course Maintenance Building, City of Edmonton
LOCATION:	12030 – River Valley, NW
BUILDING TYPE:	Maintenance and administrative building
TOTAL ROOF AREA:	Not provided

Ecoroof details

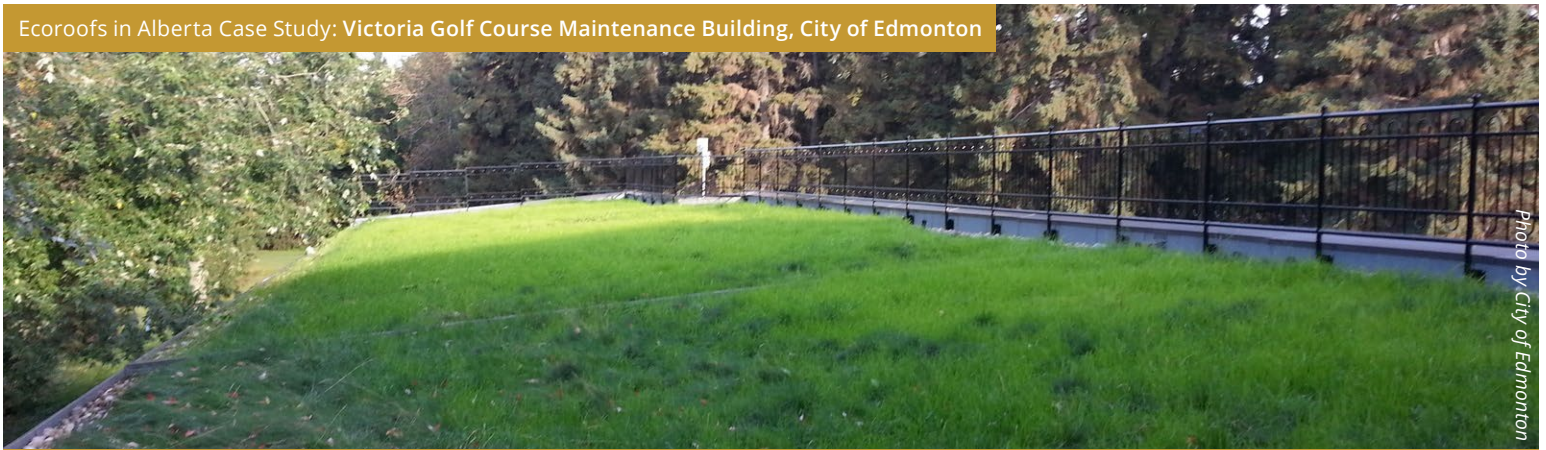
An aerial view of this ecoroof shows that it blends in perfectly with the lush vegetation of the City of Edmonton's Victoria Golf Course in the Edmonton river valley.

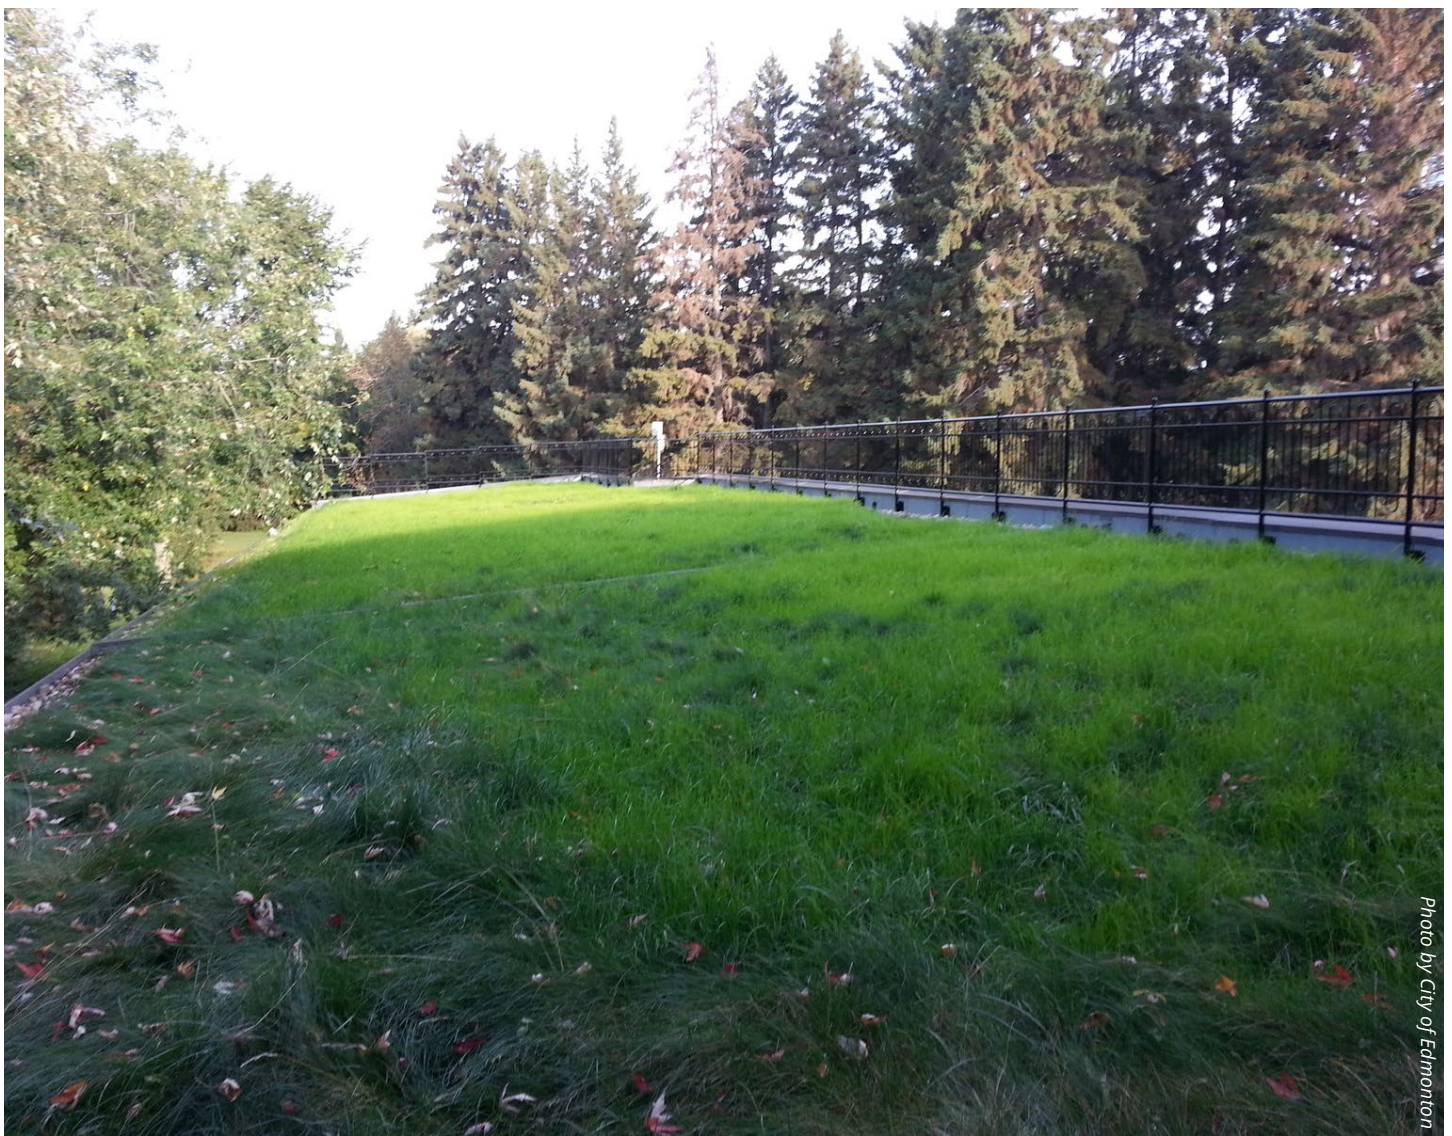
This ecoroof provides excellent insulation in winter and cools down the maintenance shop during summer. The roof is also visually enjoyed by the public patrons of the Victoria Golf Course.
